FORM B - BUILDING

MASSACHUSETTS HISTORICAL COMMISSION
294 WASHINGTON STREET, BOSTON, MA 02108

Address 57 Bedford Street

Historic Name Lexington Lumber

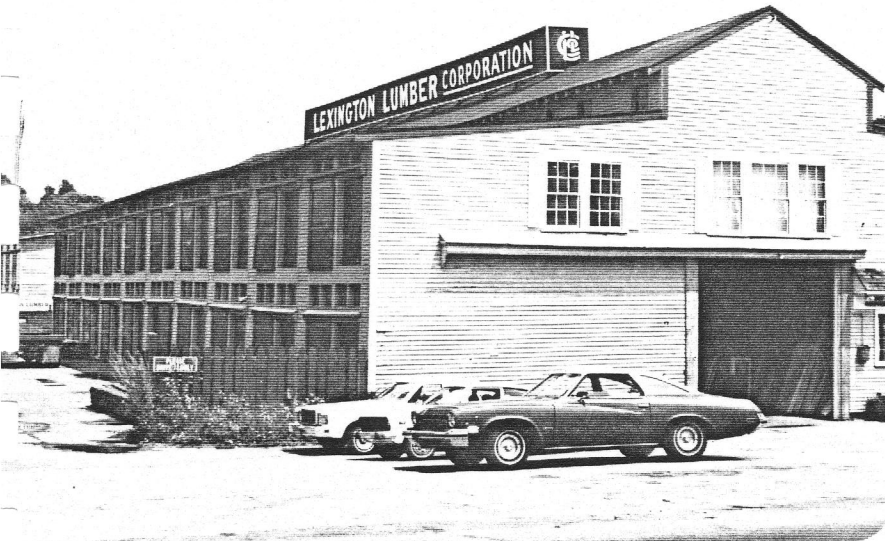
One of three industrial buildings to survive in Lexington Center, this building, although built in 1912, is in the style of a nineteenth century clerestory-monitor-roofed mill. It has seen little change since its original construction. Also noteworthy is the brick structure immediately to the north. Apparently always a Lexington Lumber Company building, it is in the style of an early twentieth century garage. There are three elliptical arches fitted with garage doors. A slightly peaked parapet finished with cyma reversa curves at

either side surmounts the facade and masks a gable roof. Lexington Lumber Company's initials in rather art nouveau lettering are in a medallion at the center of the parapet. There are two large wooden storage sheds to the rear of the property.

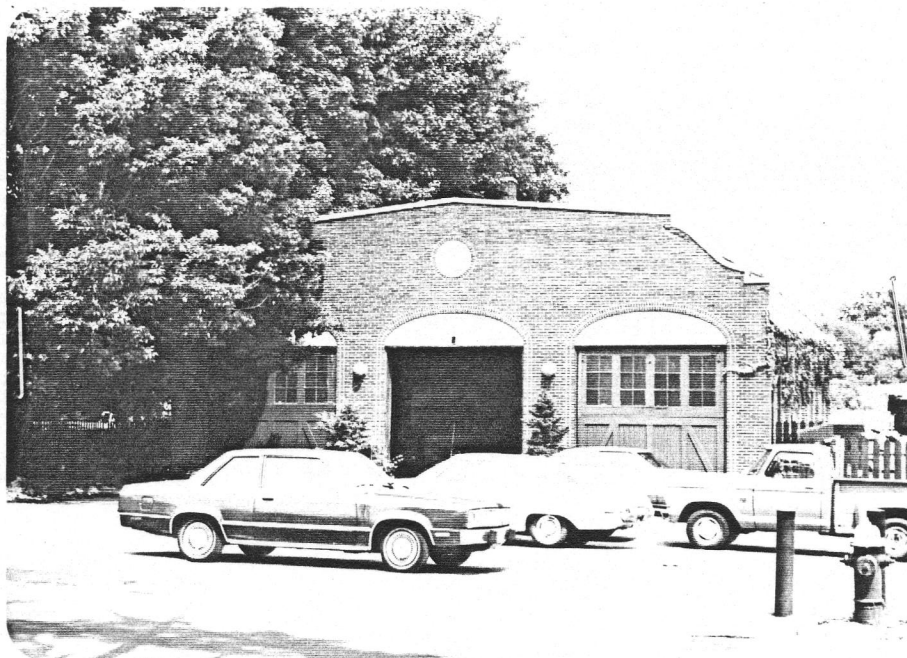
Garage (#609)

"One of the oldest, continually operating businesses in Lexington . . . the Lexington Lumber Company [was] formerly known as Whitcher's Grain Mill. It began selling lumber in 1883 behind what is today the Bay Bank-Harvard Trust Company on Massachusetts Avenue. The company moved to its present location in 1912" (Kelley 1980:30). George Briggs and William Smith were the owners when these buildings were built. An entry on the 1918 Sanborn map indicates that the brick building was built in 1913.
